# **Assessment of Dam Safety of Coal Combustion Surface Impoundments**

**Indianapolis Power & Light Company**

**Eagle Valley Generating Station**

**November 15, 2010**

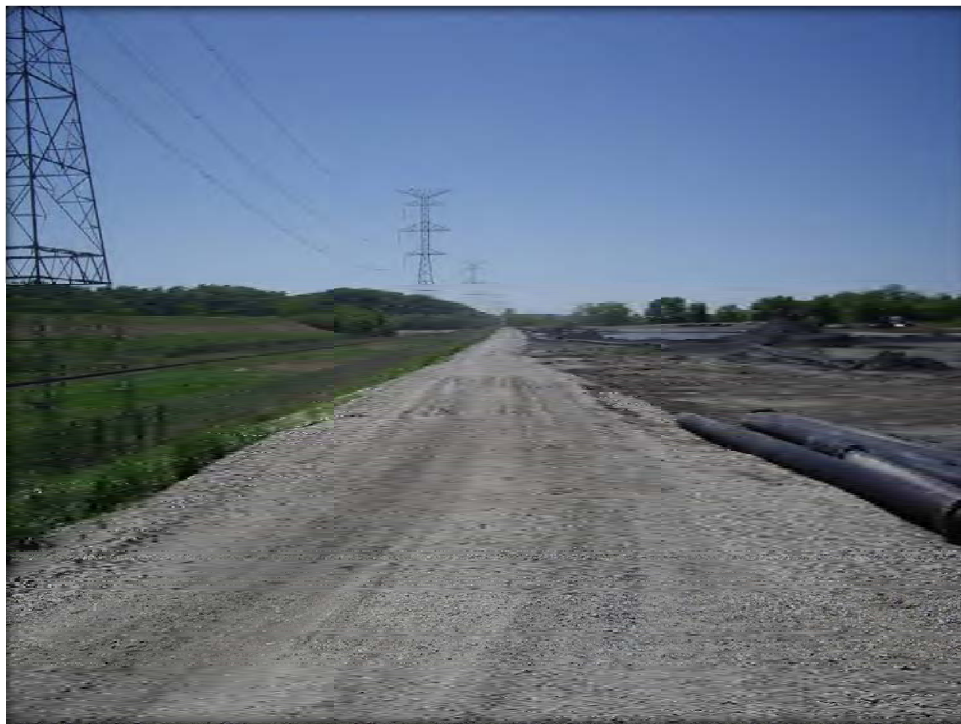
The crest of the Pond A embankments appeared to generally be in fair condition (Photos 2, 8, 14, 16, 19, 22, 24, 27, 30, 34, 43, and 44). The crest was approximately 15 feet wide with exception of the truck turn around area where the crest was significantly wider. The crest consists of a compacted gravel access road around the perimeter. Three low spots were observed in the crest (Photos 2, 14, and 28). Two of the low spots appear to be from recent truck traffic rutting the crest. The low spot on the east embankment observed on 4/28/10 was filled in by an IPL contractor to improve conditions for traffic purposes. IPL indicated that the low spot on the divider embankment near the outlet pipes (Photo 28) is an overflow spillway. There are no records in the information provided to CDM to indicate this was a design feature. There were no deficiencies observed in this area.

2. Pond A – East embankment crest looking south.

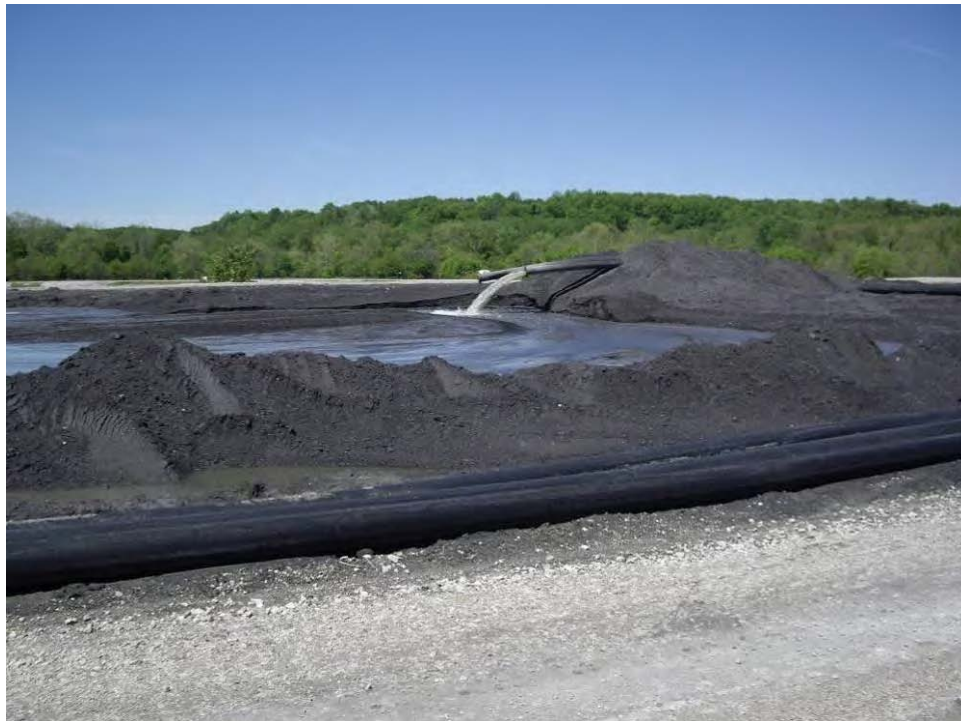
Two (2) 10-inch-diameter High Density Polyethylene (HDPE) pipes sluice CCW waste into Pond A (Photo 6). In addition, a third 10-inch-diameter HDPE pipe sluices plant wastes into Pond A (Photo 10). Pond A is used as the primary settling pond. Floating booms were installed in the pond to direct flow and increase the settling time in the pond. Pond A is connected to Pond B by two (2) 30-inch-diameter Corrugated Metal (CMPs ) with an invert elevation of El. 626 (Photo 28, 29 and 30). At the pipe inlets, there is a floating boom wrapped around the inlets and vertical pipe T's are connected to the ends to serve as a hood to reduce the potential for surface debris from clogging the pipes. IPL staff stated that a low spot in the crest in Pond A is an emergency overflow spillway (Photo 28). The spillway is approximately 50 feet wide with the crest at El. 628. This "emergency spillway" is not included on any design plans.

6. Overview of two 10-inch-diameter HDPE discharge pipes into Pond A, looking northwest.

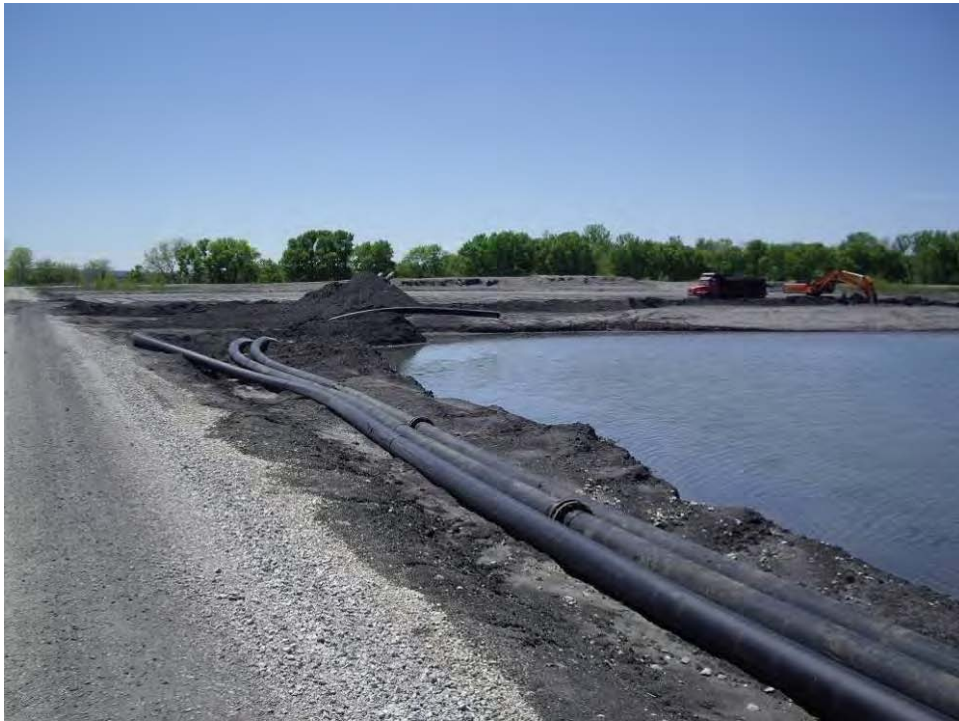
8. Overview of three 10-inch-diameter HDPE discharge pipes into Pond A, looking southwest.  
Note two right-most pipes are disconnected.

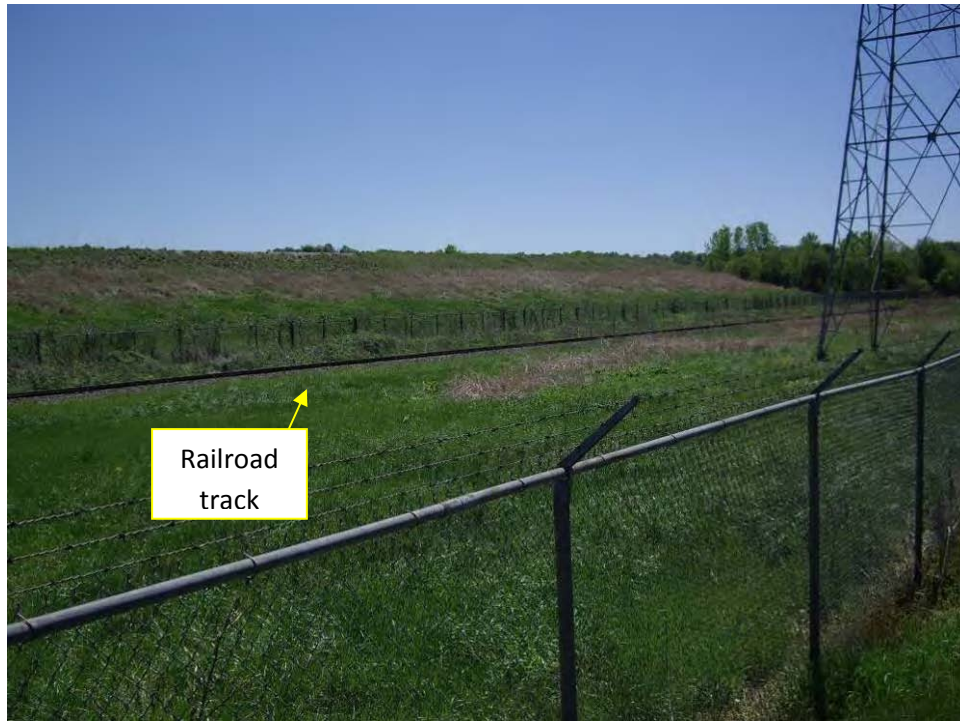
9. Overview of Pond D west embankment exterior slope from toe of Pond A east embankment. Note change in vegetation type at the three vertical expansions.

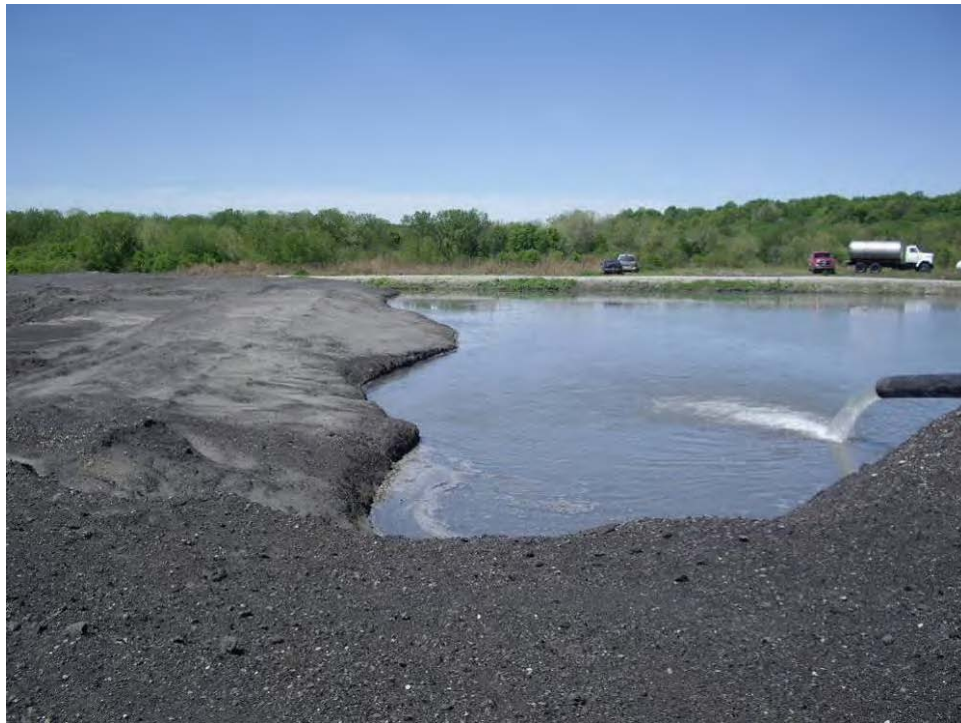
10. Overview of 10-inch-diameter HDPE discharge pipe into Pond A, looking west.

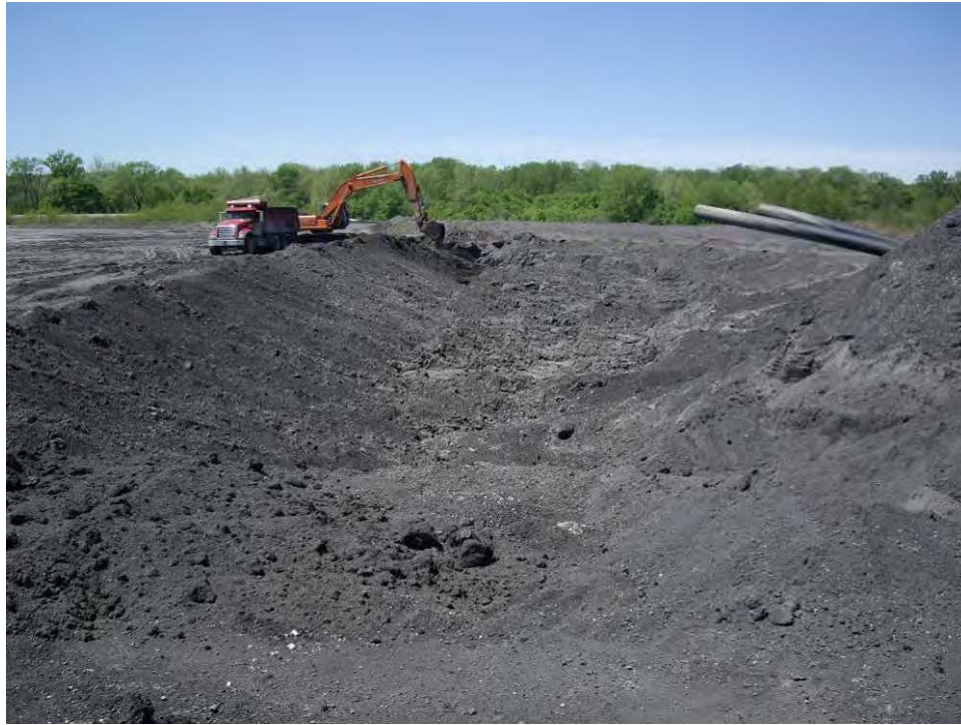
11. Overview of ash excavation in Pond A looking west. Ash being used as fill to repair Ponds D and E..

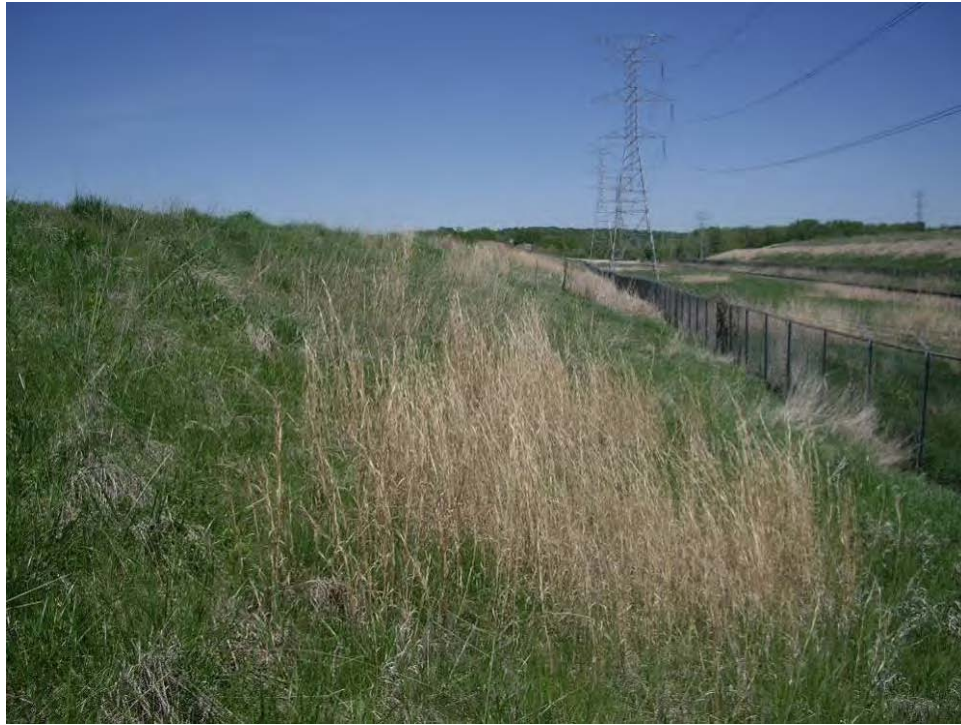
The exterior slopes of the Pond A embankments appear to be in fair condition. The exterior slopes on the north, south, east, and west embankments ranged from approximately 2.5H:1V to 3H:1V (Photos 1, 15, 20, 23, 25, 45, and 46). The exterior slope on the embankment between Pond A and Pond B (divider embankment A/B) and embankment between Pond A and Pond C (divider embankment A/C) ranged from approximately 2H:1V to 3H:1V (Photos 28, 33, 34, 38, 40, and 42).

15. Pond A – East embankment exterior slope looking north.

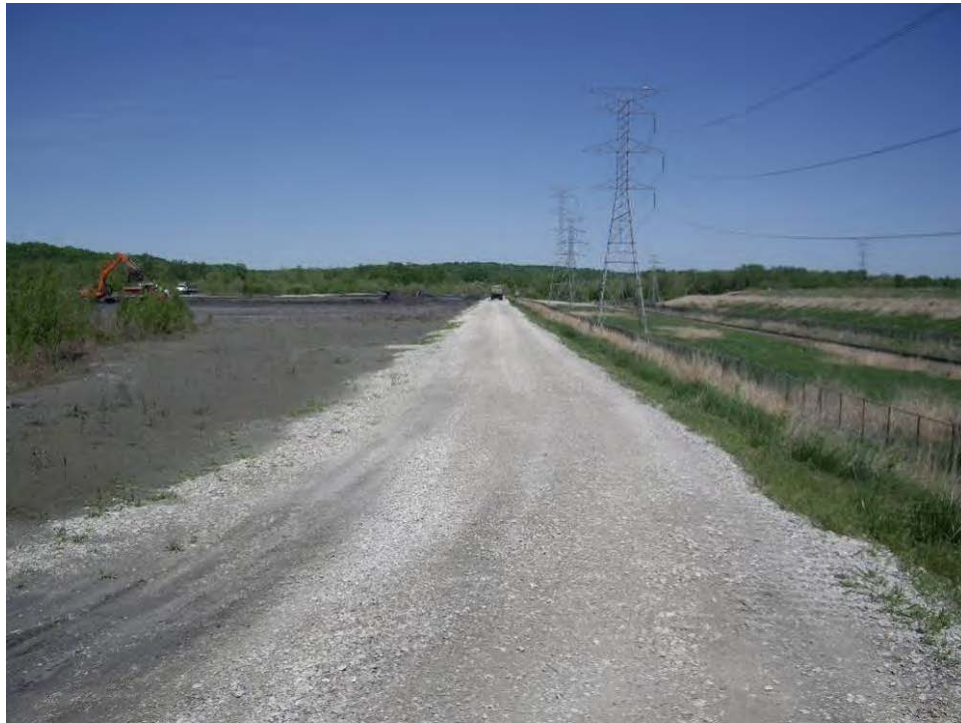
16. Pond A – East crest looking north.

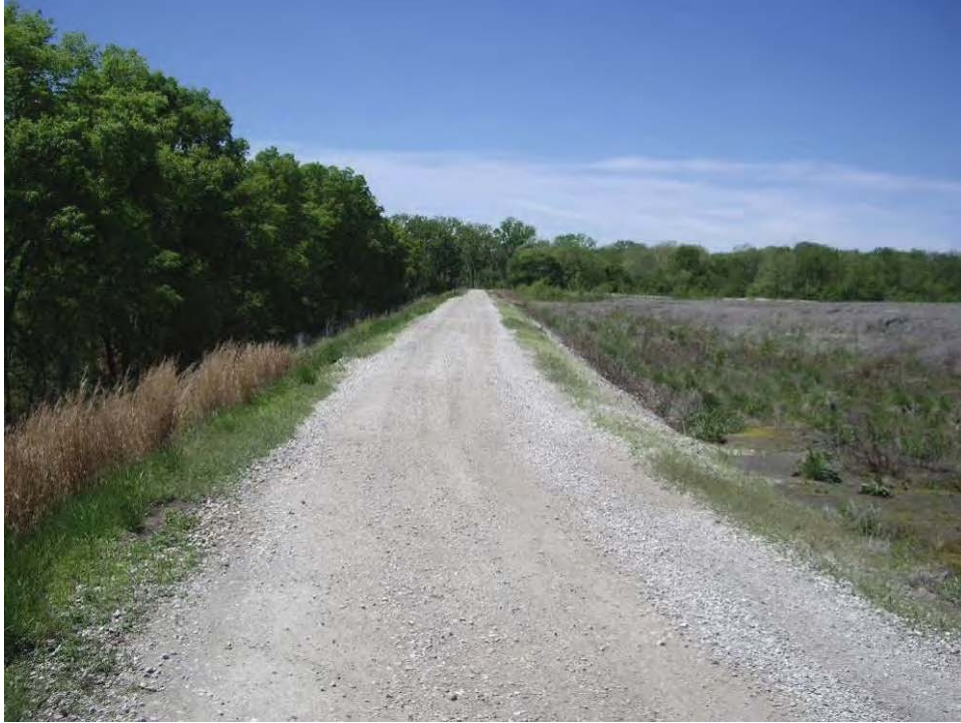
19. Pond A – South embankment crest looking west.

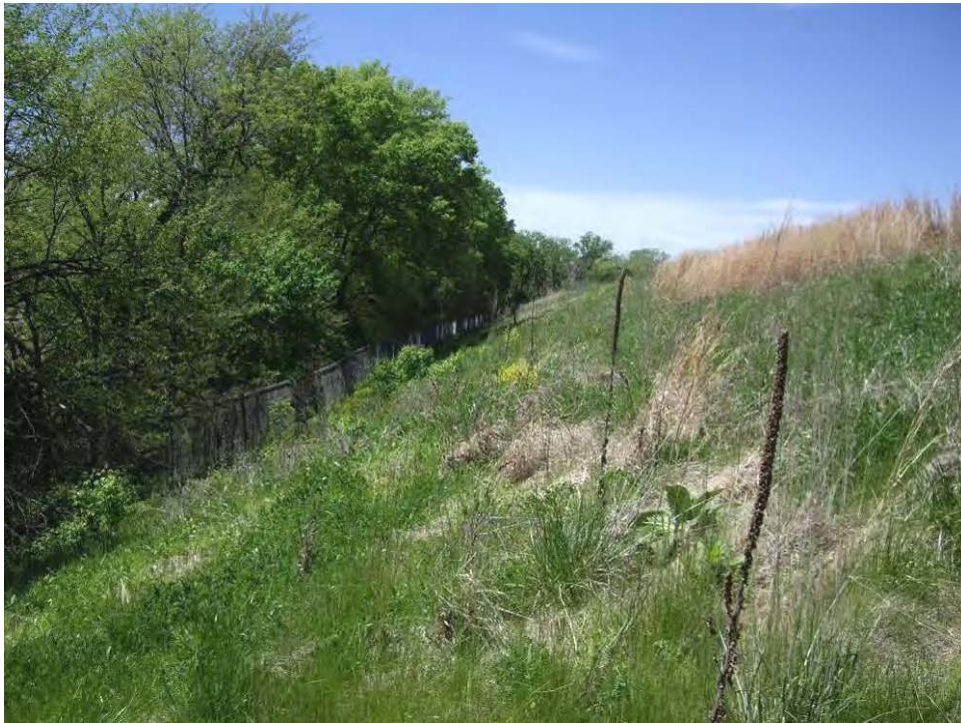
20. Pond A – South embankment exterior slope looking west.

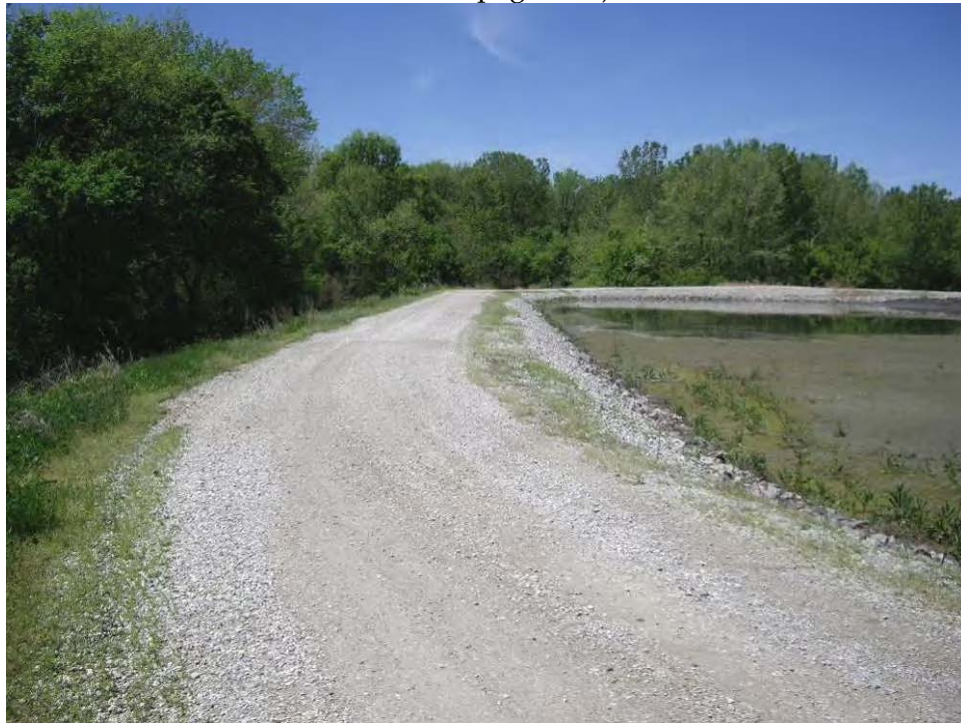
22. Pond A – South embankment crest, looking west.

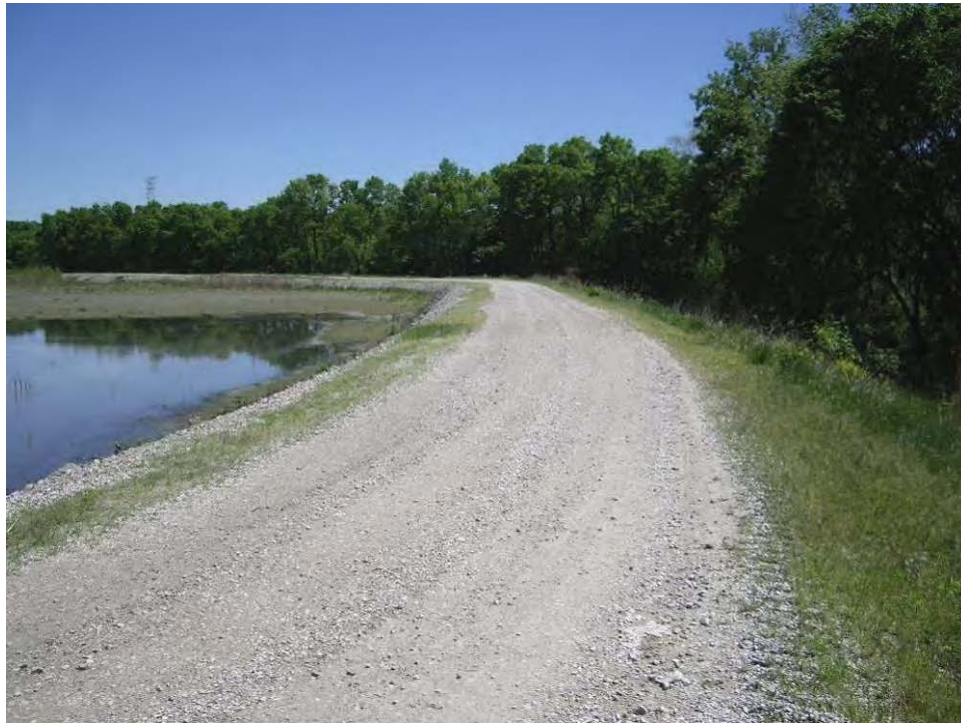
24. Pond A – South embankment crest, looking southeast.

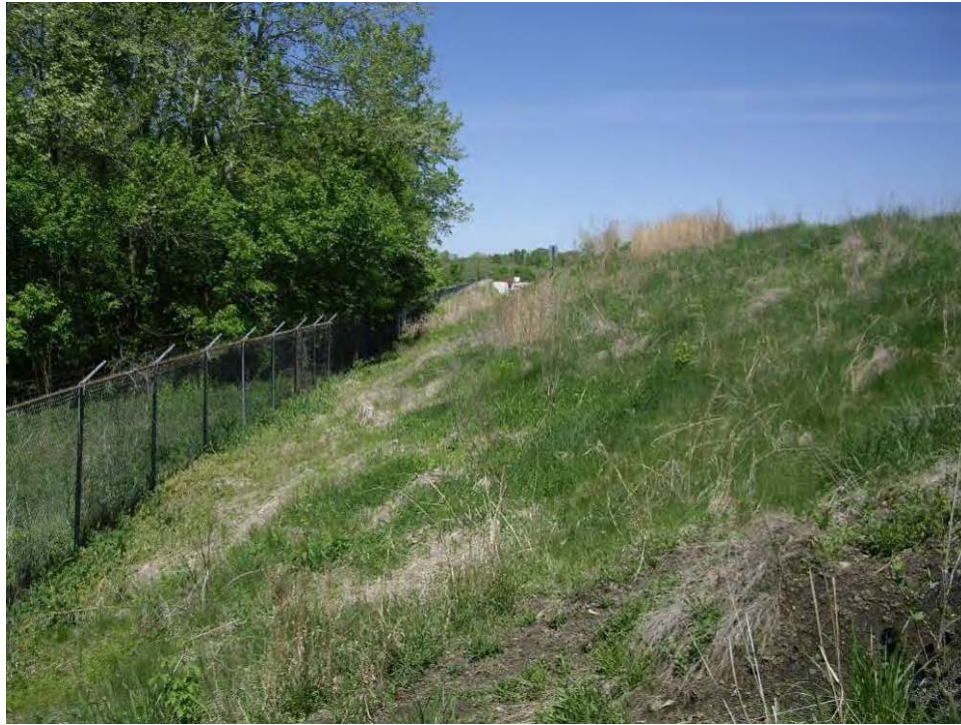
25. Pond A – West embankment exterior slope, looking north.

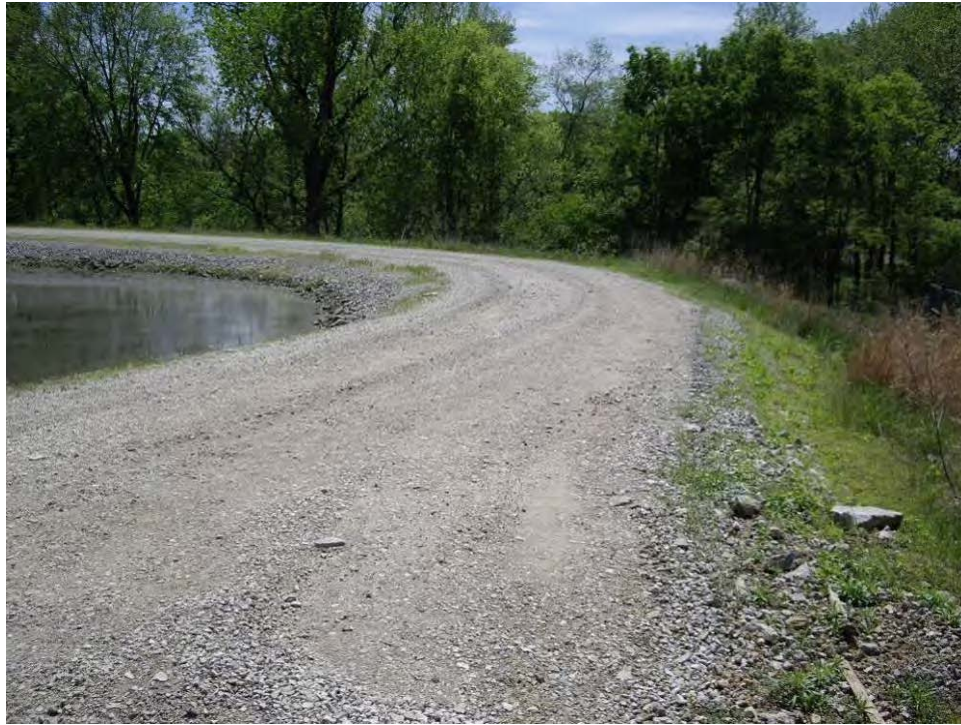
27. Pond A – West embankment crest, looking south.

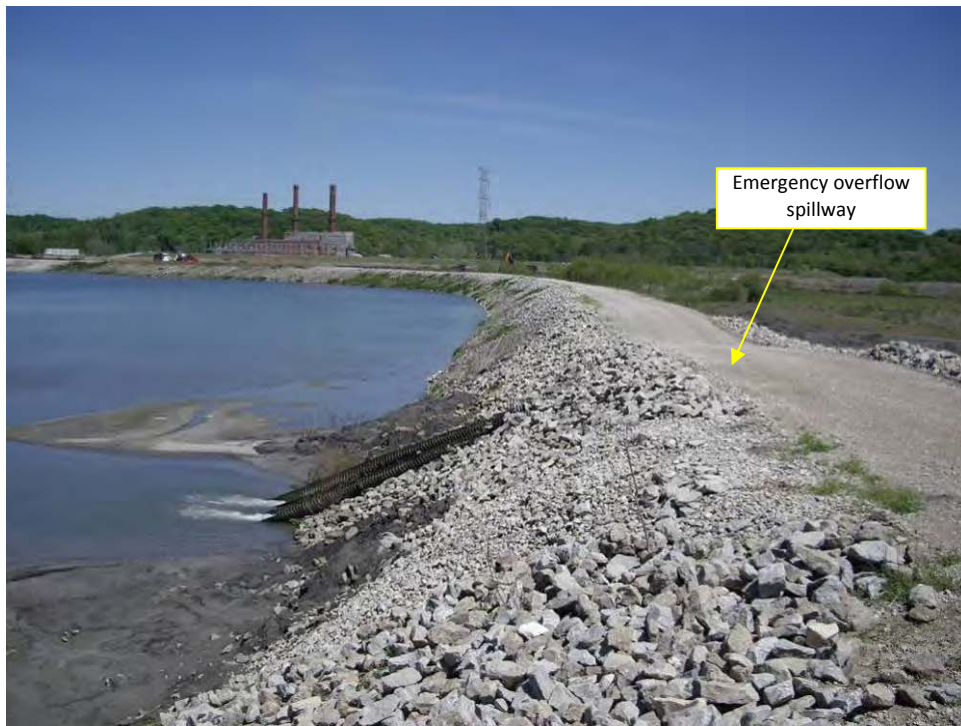
28. Pond A/B – north slope of divider embankment, looking east.

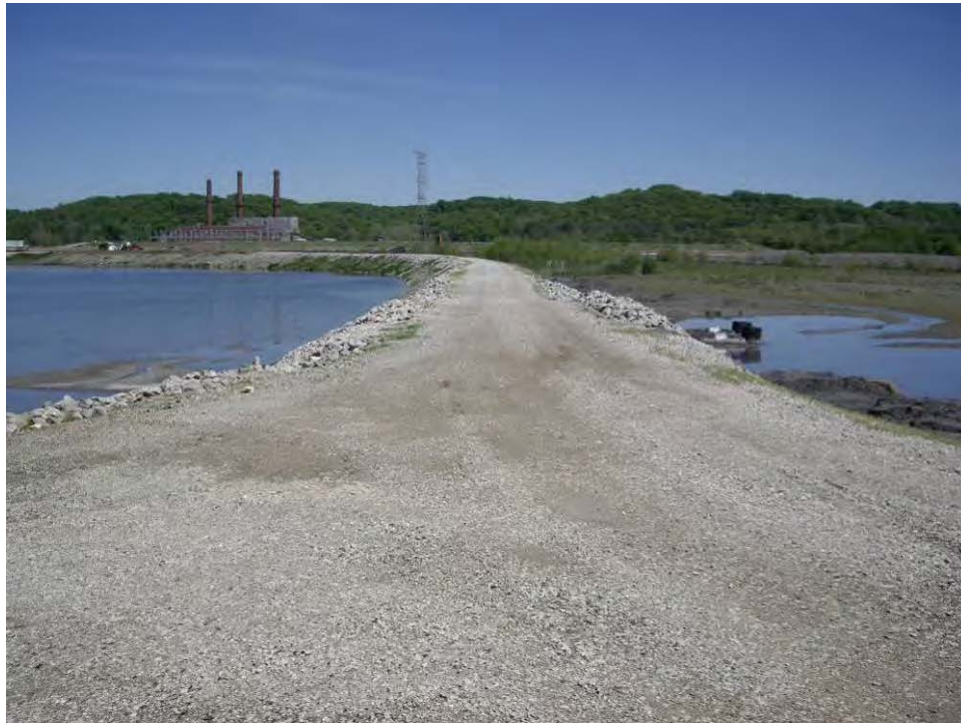
30. Pond A/B - crest of divider embankment, looking east.

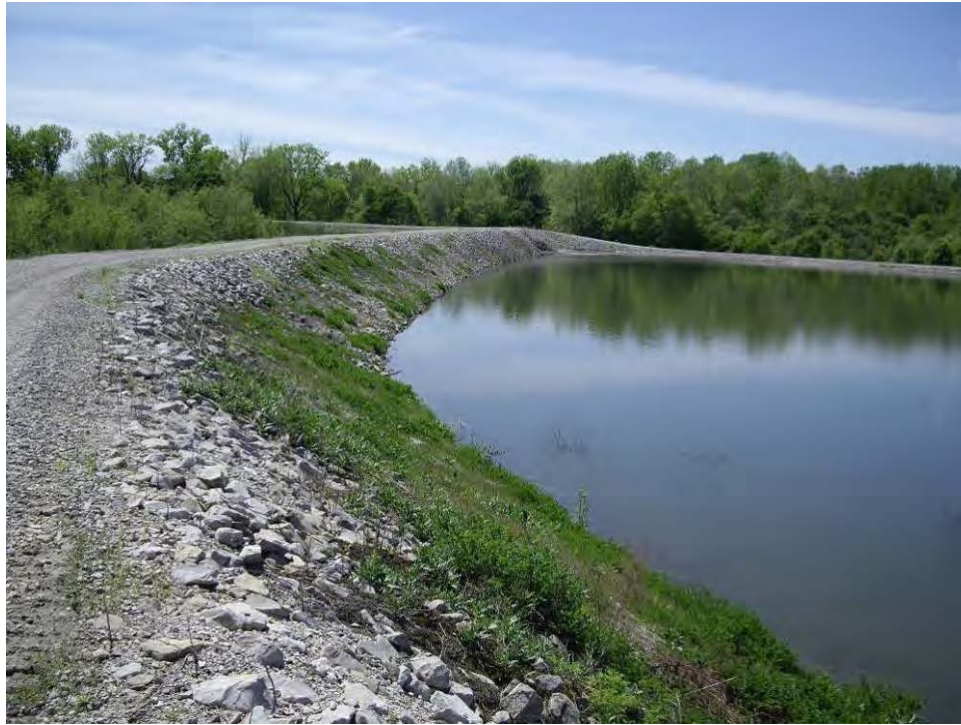
33. North slope of divider embankment A/B and Pond B west embankment, looking southwest.

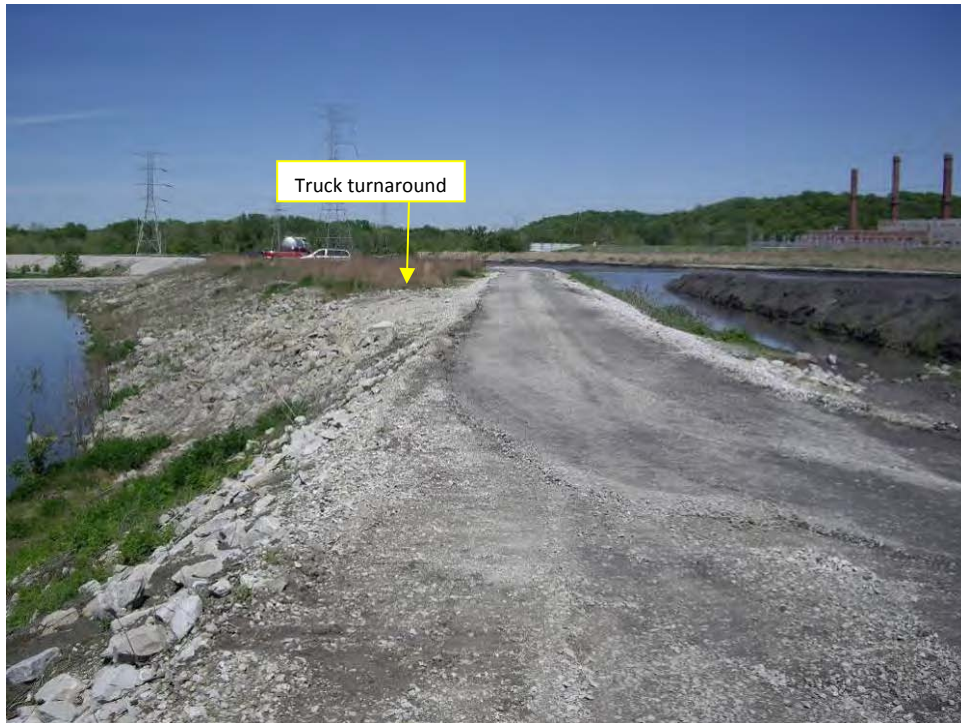
34. Crest of divider embankment A/B, looking northeast.

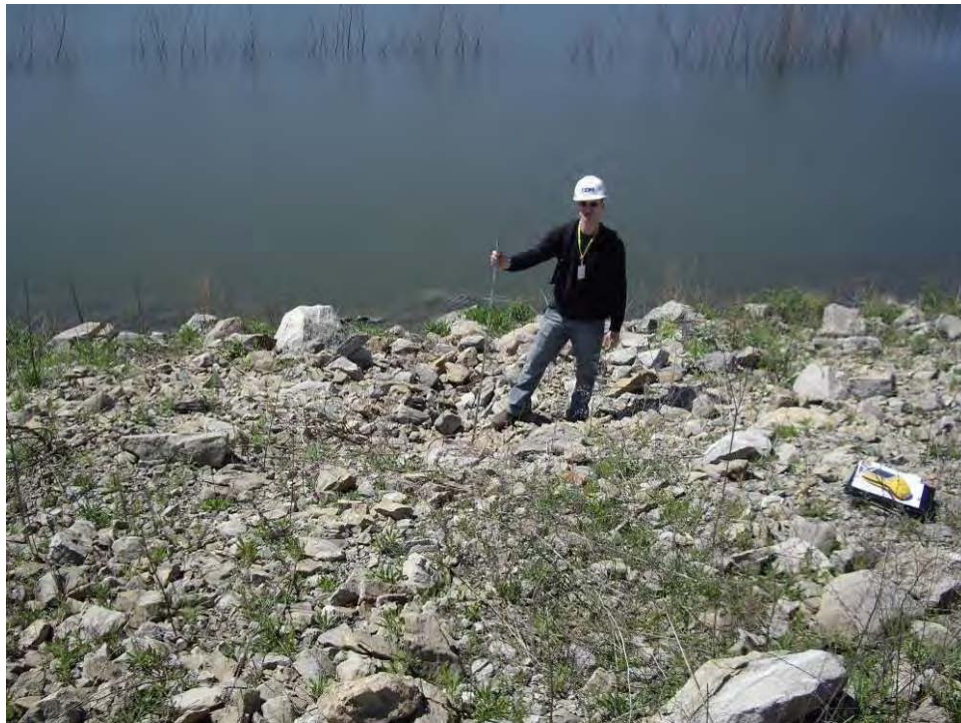
36. Depression in north slope of divider embankment A/B.

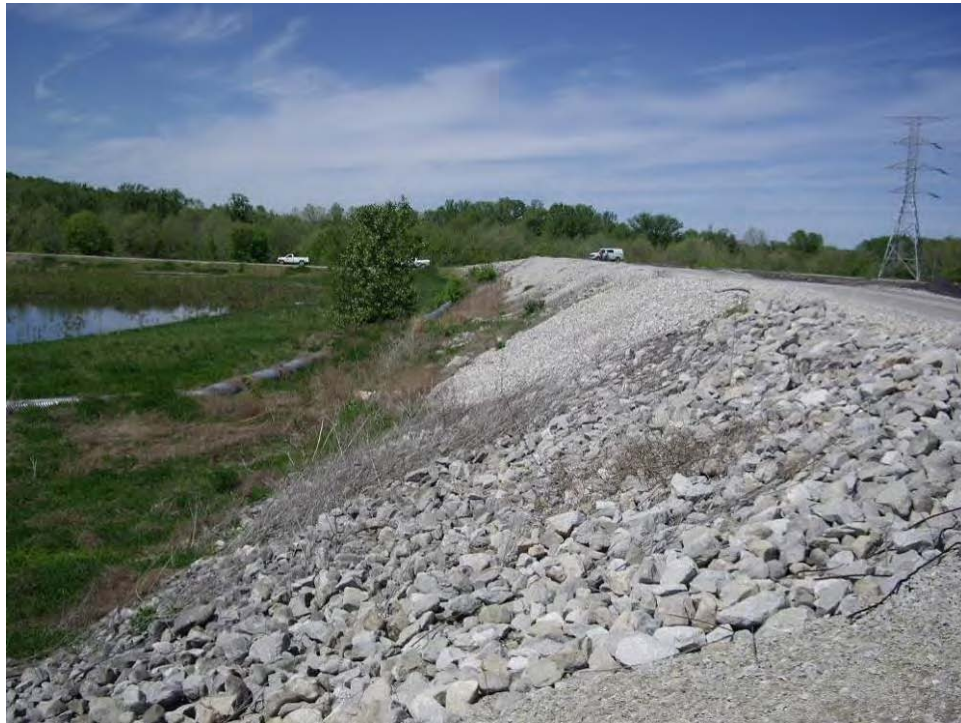
40. West slope of divider embankment A/C from Pond B, looking north.

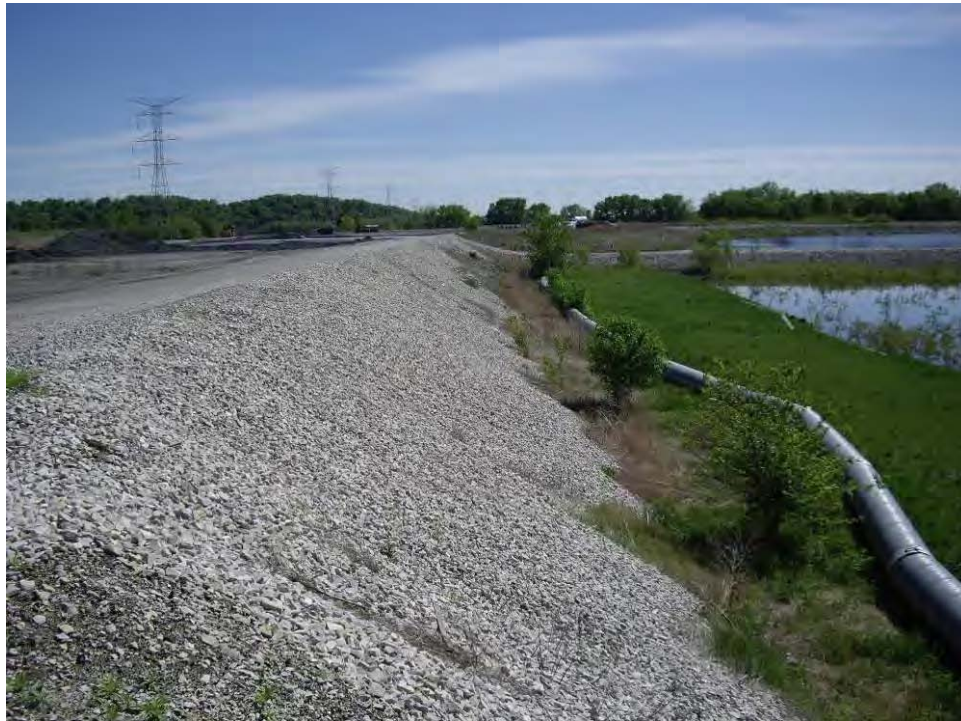
42. West slope of divider embankment A/C from Pond C north embankment, looking south.

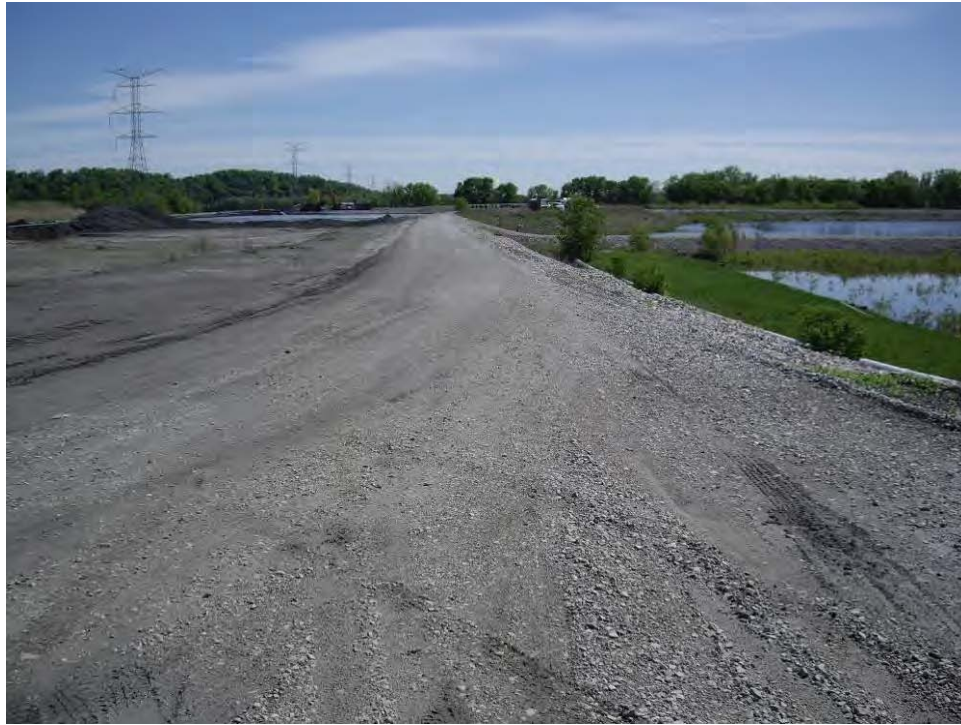
43. Crest of divider embankment A/C from Pond C north embankment, looking south.

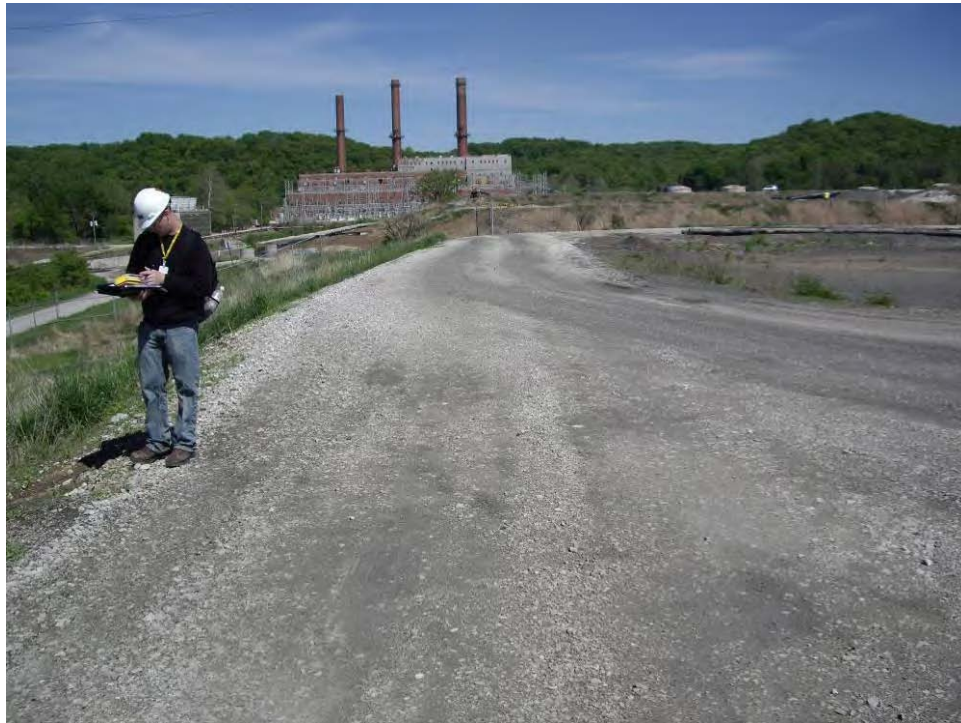
44. Pond A – North embankment crest, looking east.

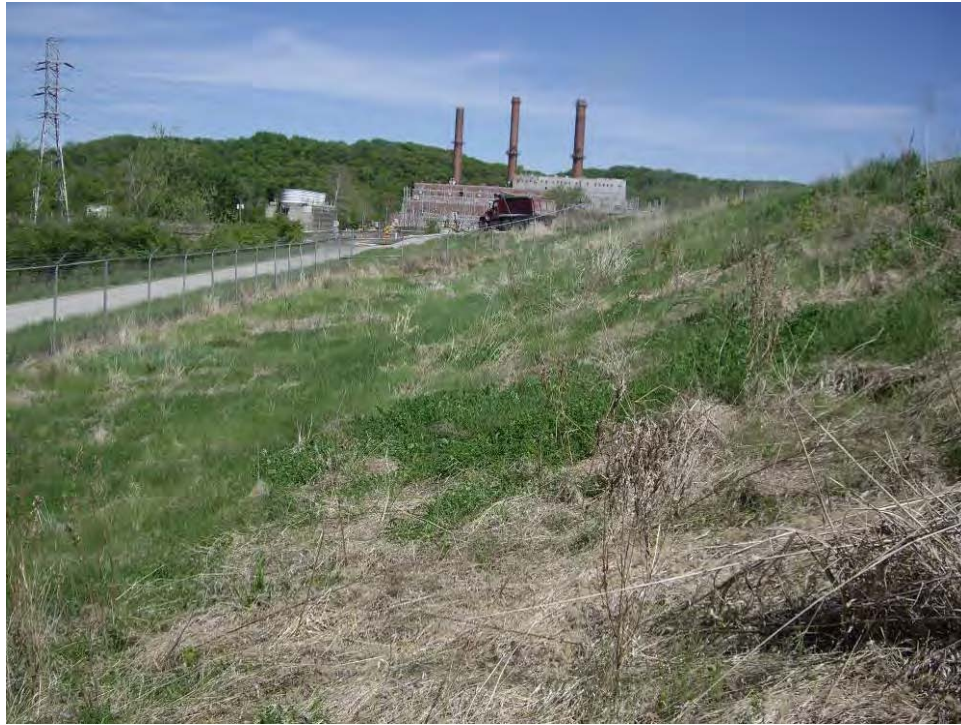
45. Pond A – North embankment exterior slope, looking east.

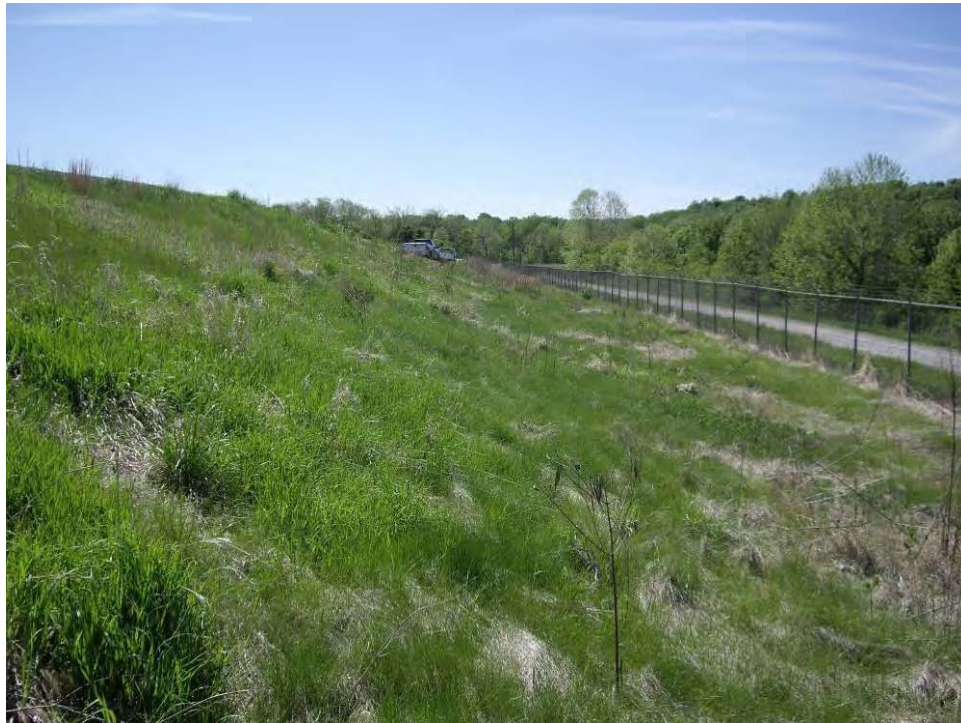
46. Pond C – North embankment exterior slope, looking west.

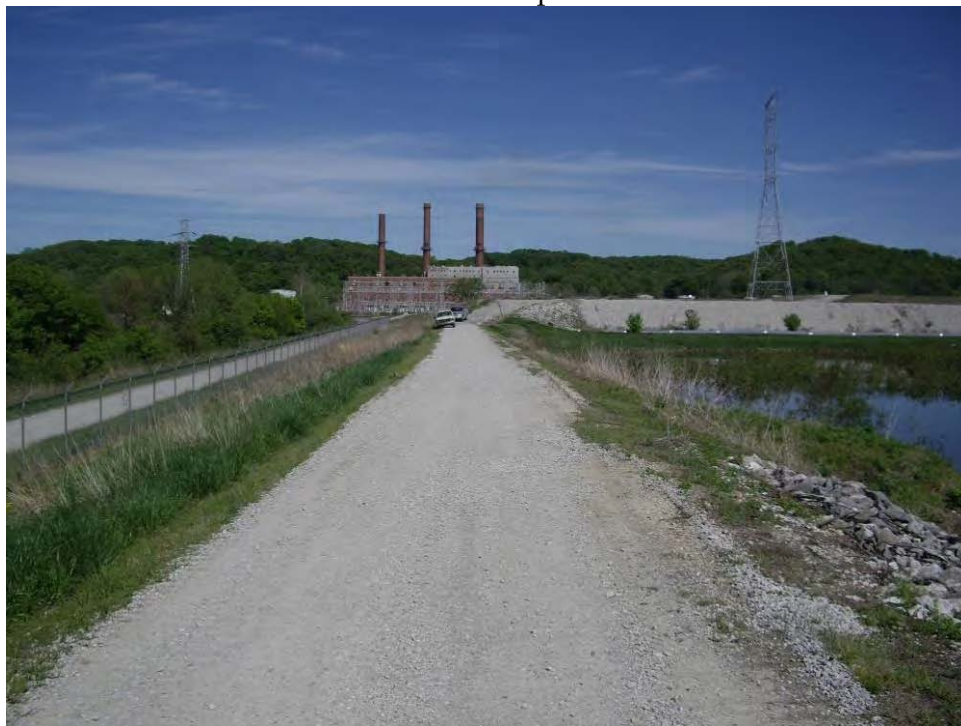
48. Pond C – North embankment crest, looking east.

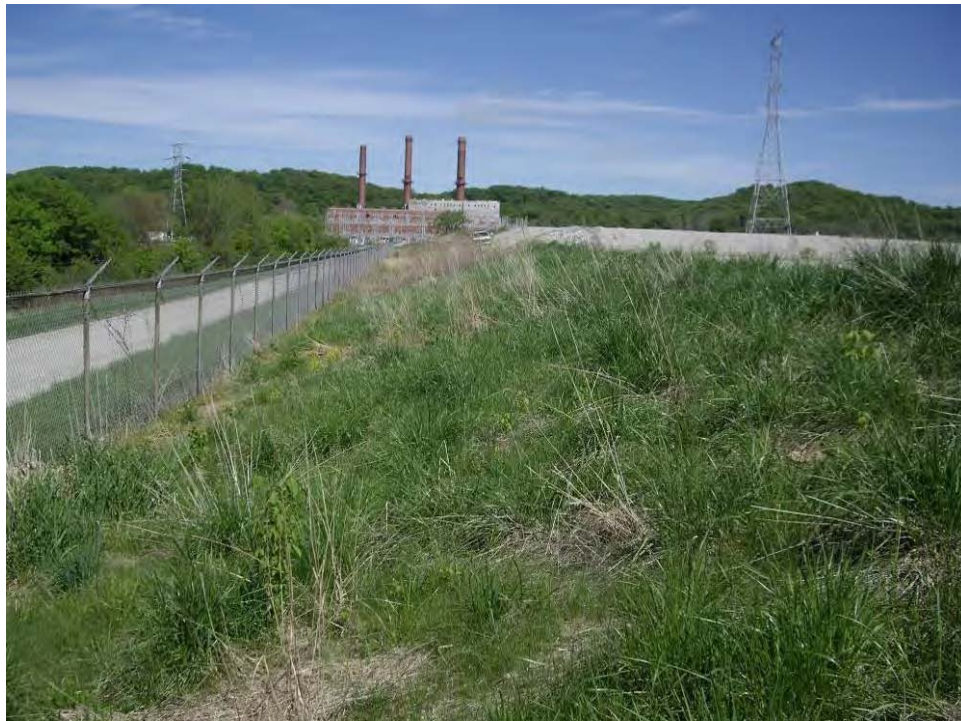
50. Pond C - North embankment exterior slope, looking east.

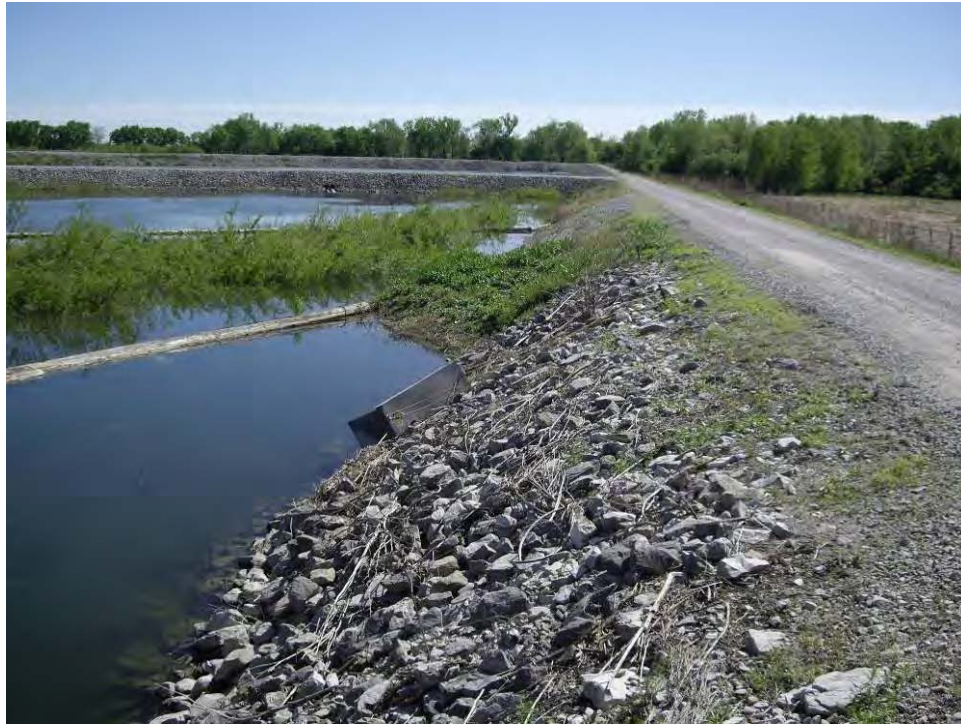
51. Pond C – West embankment interior slope, looking south.

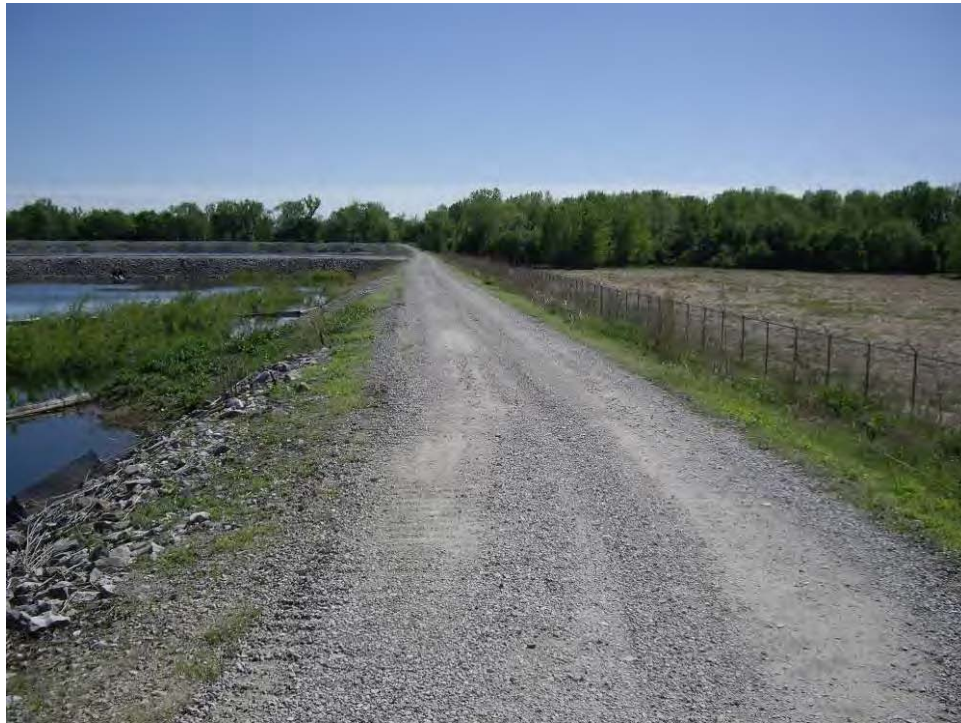
52. Pond C – West embankment crest, looking south.

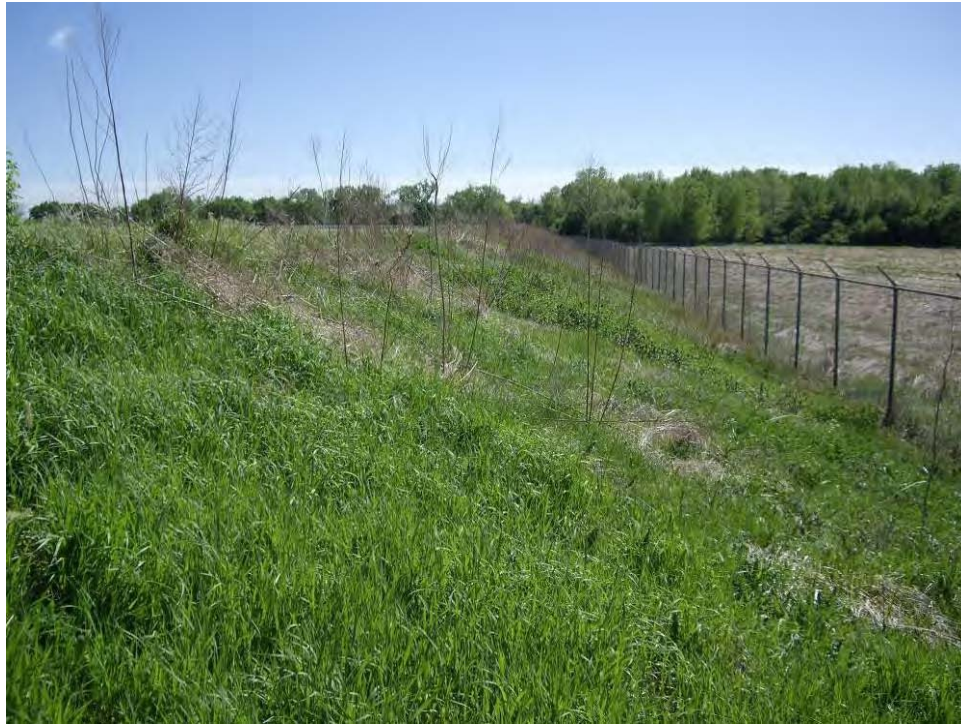
53. Pond C – West embankment exterior slope, looking south.

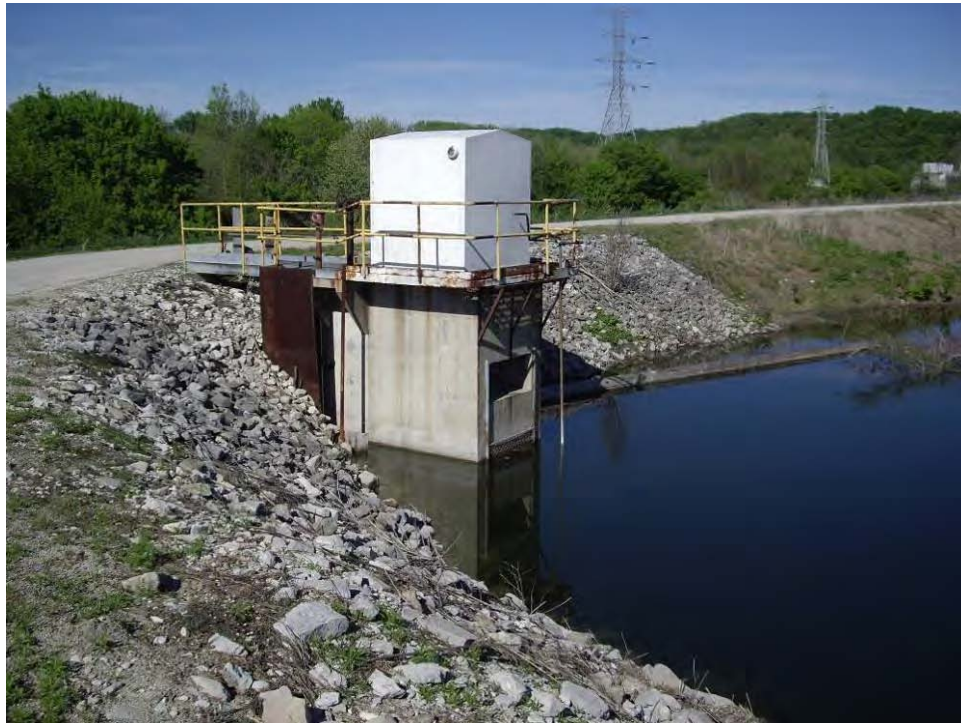
54. Pond C – Outlet structure gatehouse. Note stoplogs and butterfly valve in catwalk.
